Research Gaziantep area

Site analysis

Concepts and research

Chosen design – Karsten

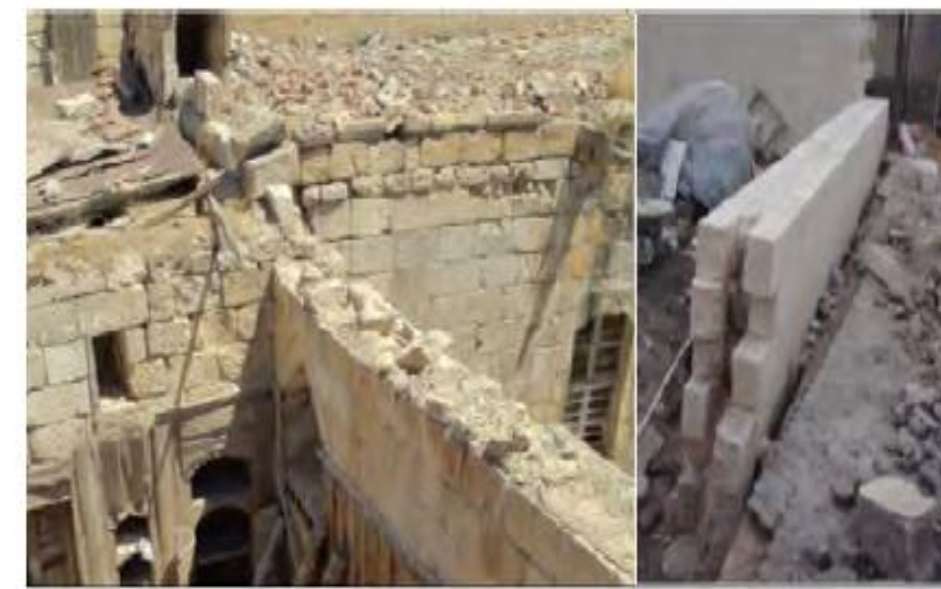
Figure 11. Use Of Natural Stone Material In WallConstruction (Taştan, 2014)

Masonry construction techniques used to create cooler living environment.

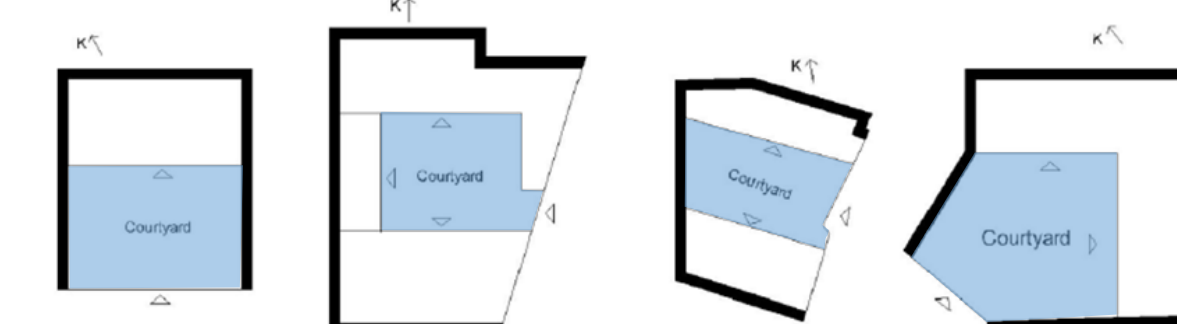
Figure 8. Types of Traditional Gaziantep Houses (Adopted from, Taşdoğan, A. D. 2008)

Because its always so hot in the summer they use the courtyard to cool.

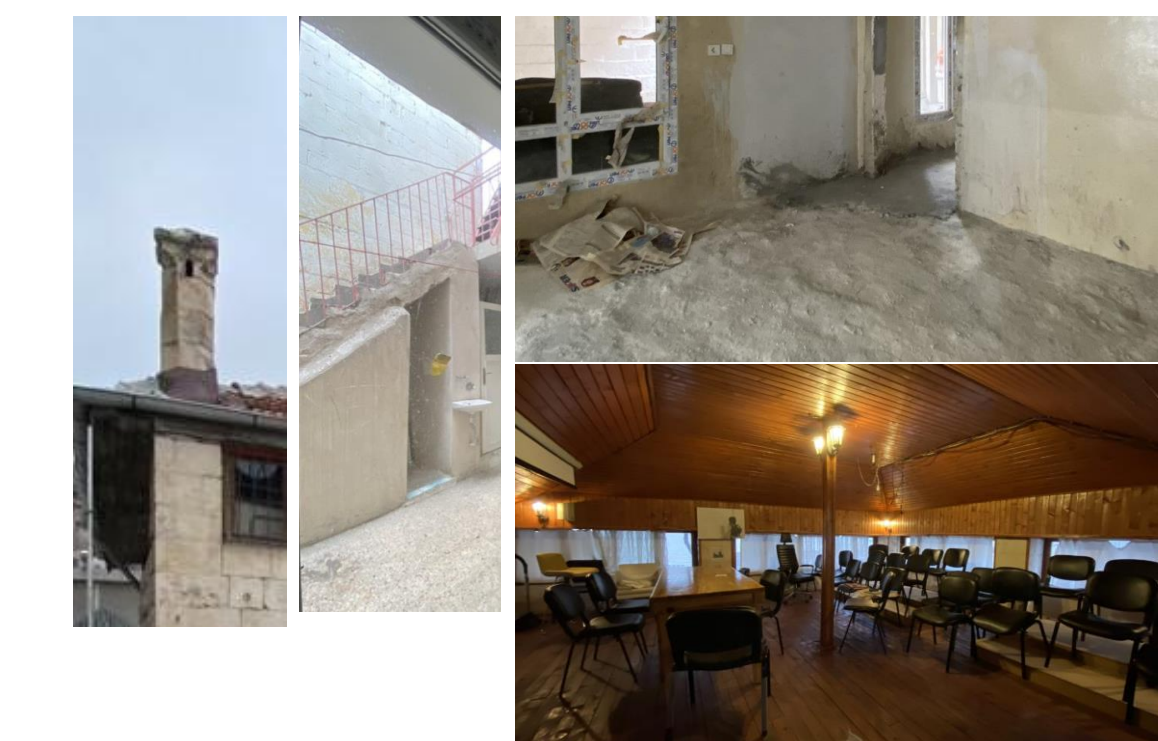
Found elements that are important for further designing

- Chimney (could be used for ventilation)
- Staircase to second floor, white house
- Unfinished floor, white house
- Dark top floor

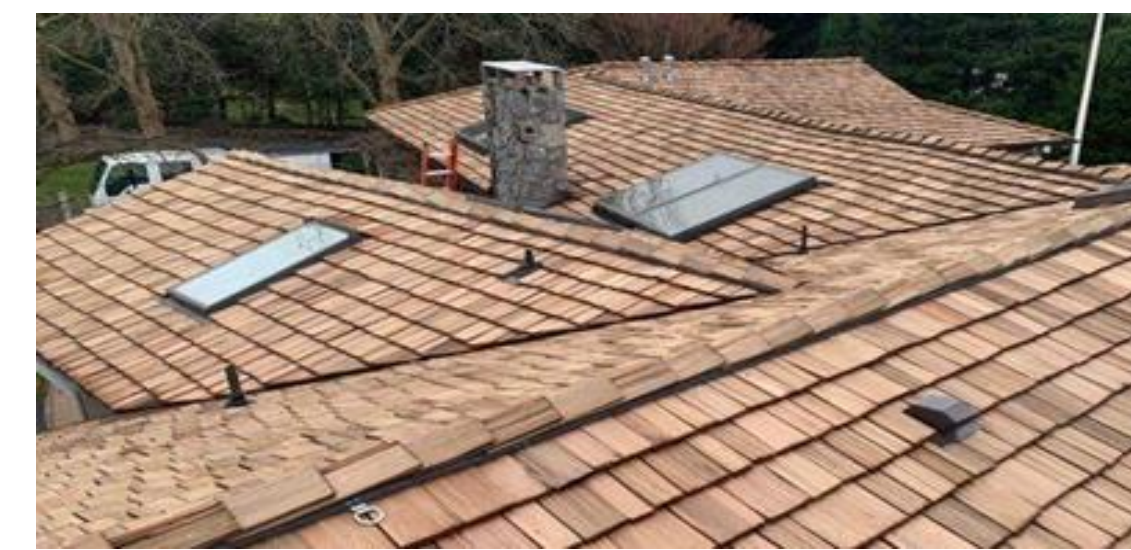
Wooden shingles for roofing. Lightweight solution instead of rooftiles

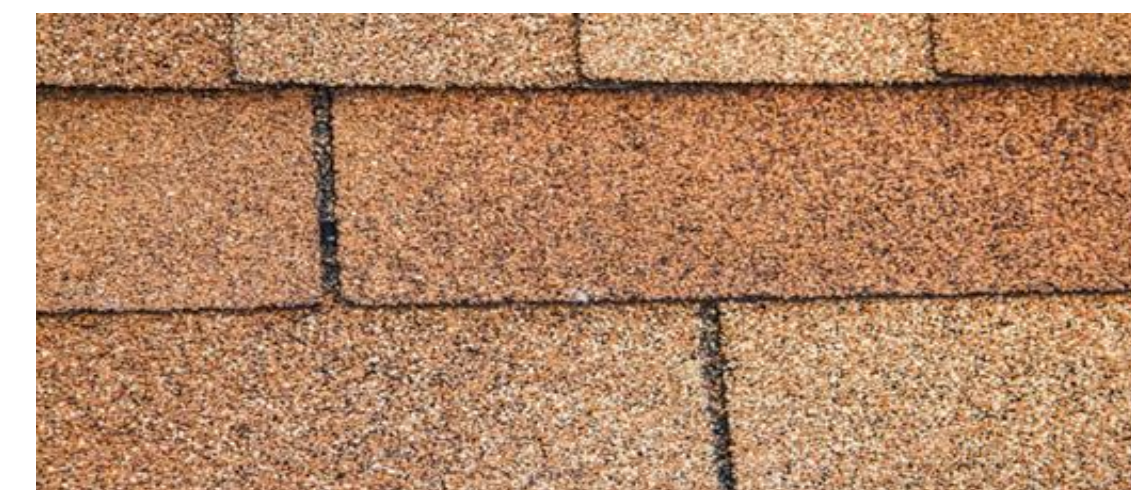
Fiberglass shingles, lightweight solution instead of rooftiles

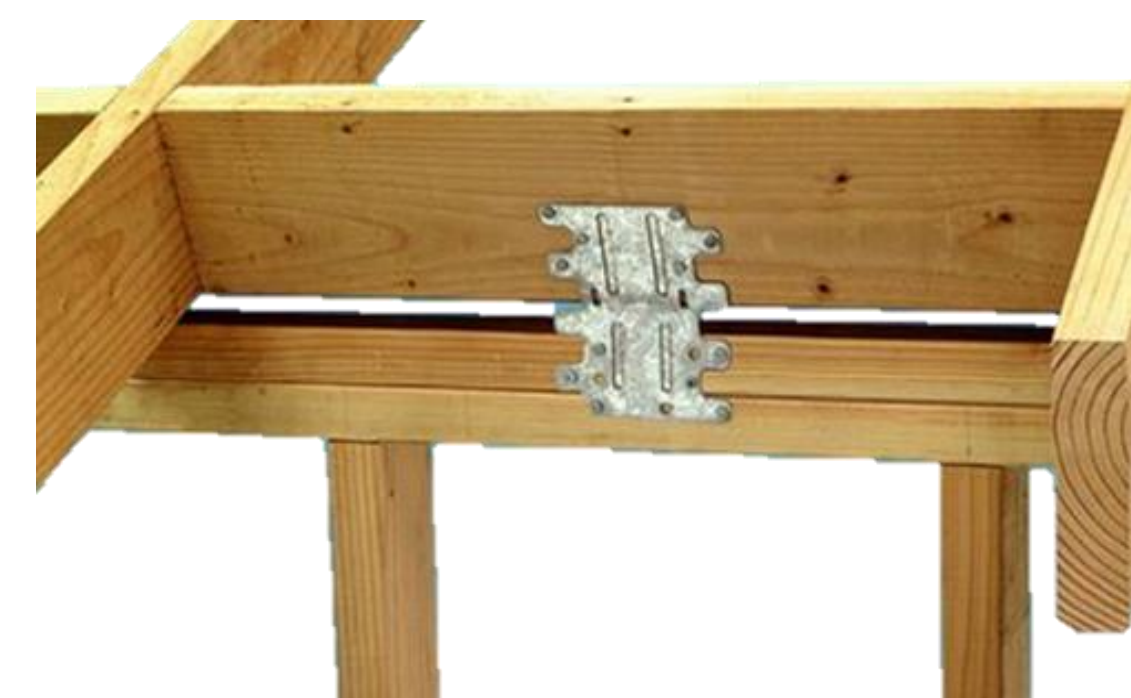
Place roof blocks between the rafters. The roof blocks help the roof rafters with transferring the earthquake lateral loads to the walls. this prevents the roof from rotating and falling during the earthquake.

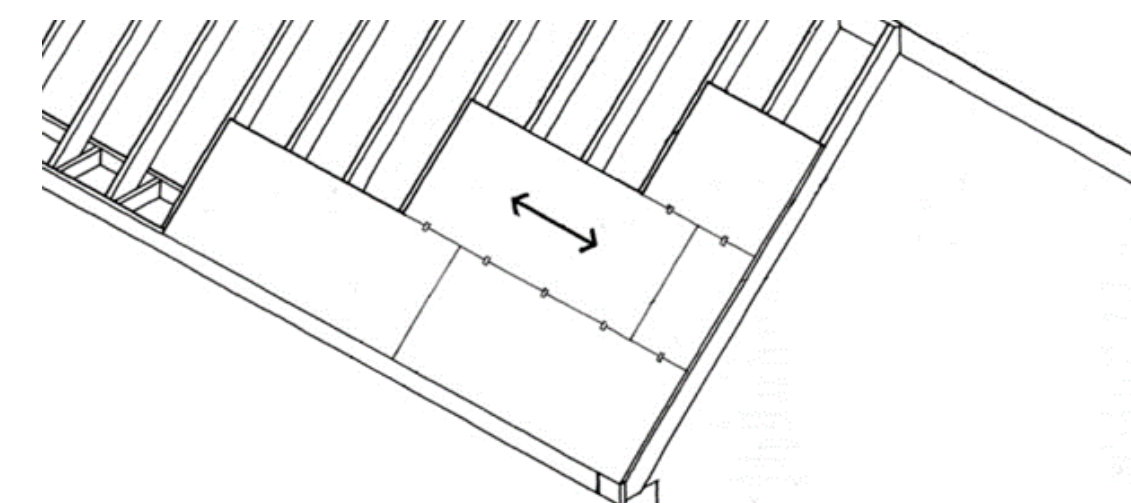
We recommend to use plywood or OSB for the roof sheathing. It is a stronger type of sheathing compared to particleboard. To make the roof earthquake-resistant, the sheathing needs to be placed perpendicular to the rafters.

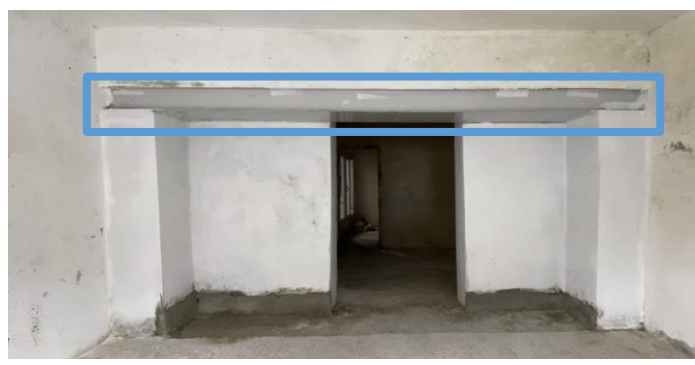
In the red you can see the bearing walls. We did this research to know what's possible to change.

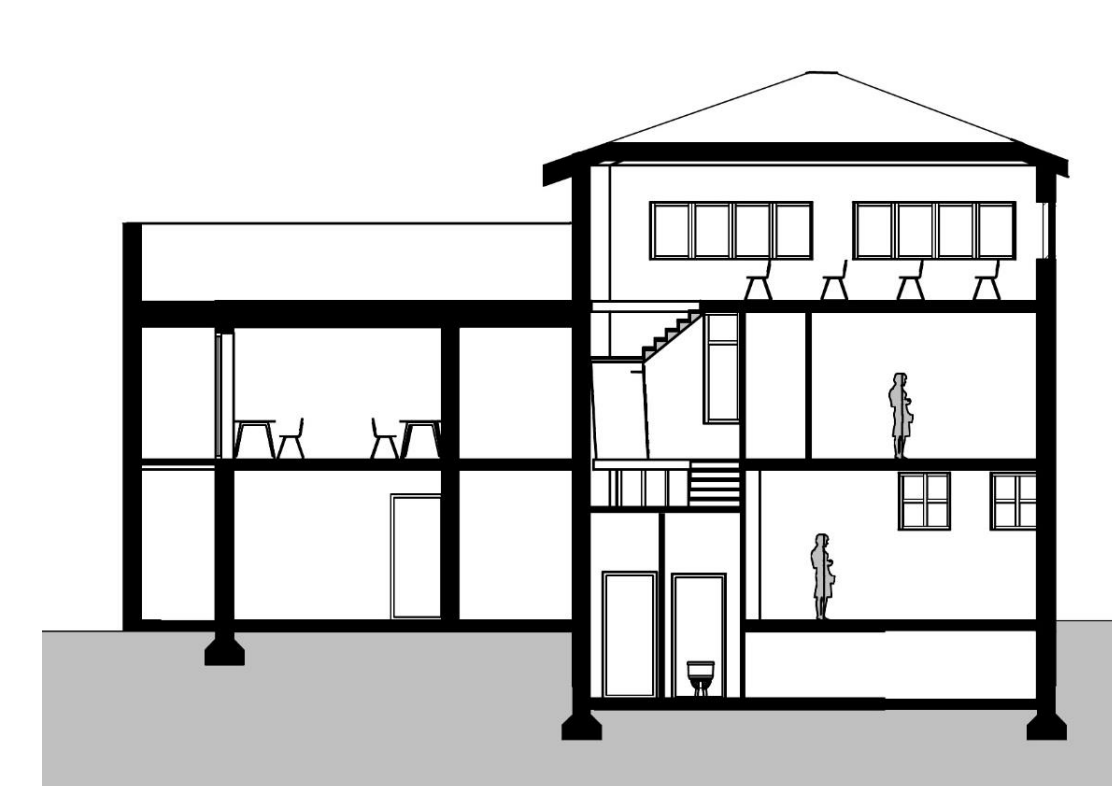
Cross section 1 1:200

3e Verdieping +10650
2e Verdieping +7650
1e Verdieping +4600
Begane grond +0

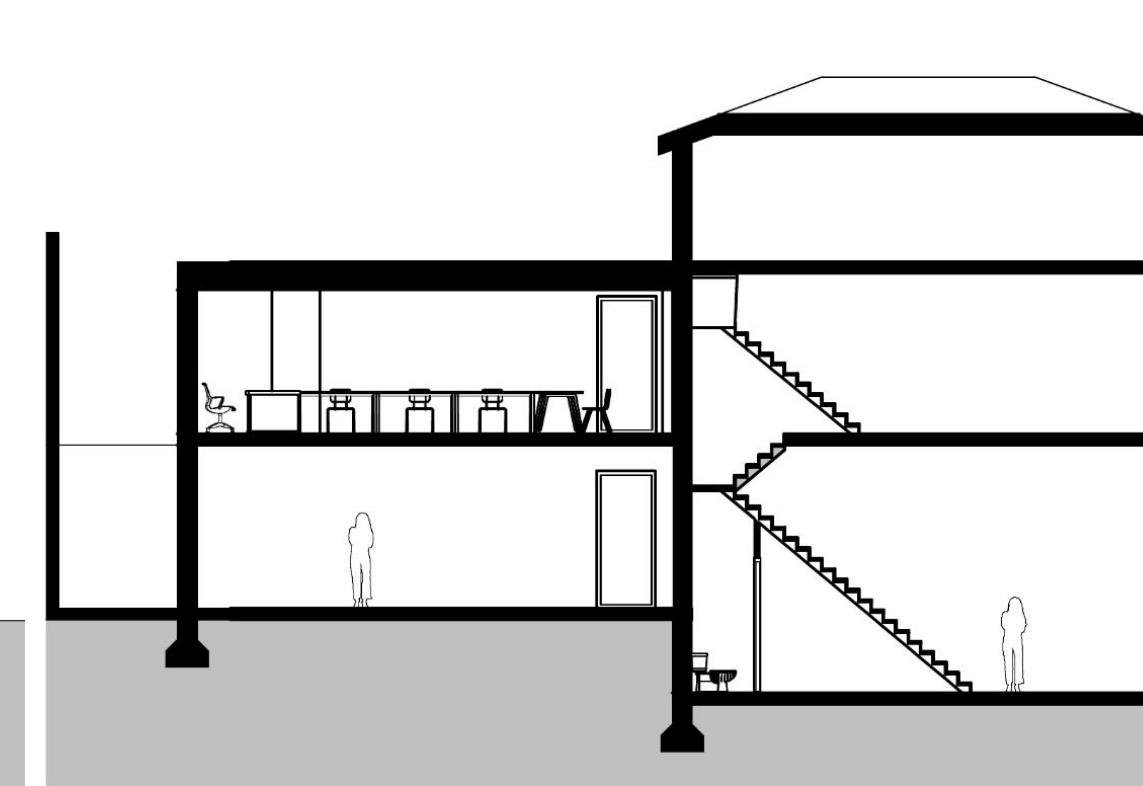
Cross section 2 1:200

3e Verdieping +10650
2e Verdieping +7650
1e Verdieping +4600
Begane grond +0

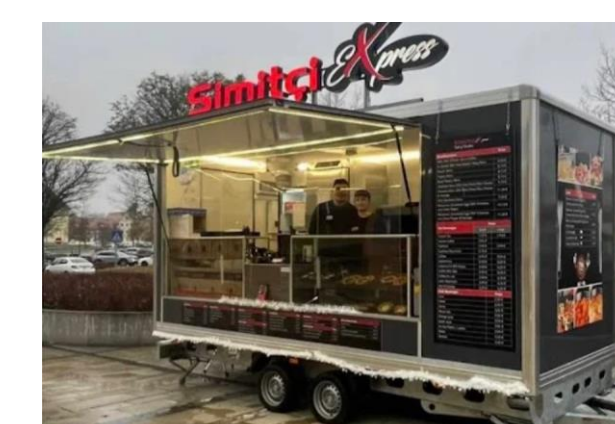
Mobile kitchen

Used to feed the children. Small and portable and will be parked in front of the white house.
